# SEM INVESTIGATION OF SILICON DIODES USING THE ELECTRON BEAM INDUCED CURRENT METHOD

1Lt Mark E. Snyder

December 1984

## Final Report

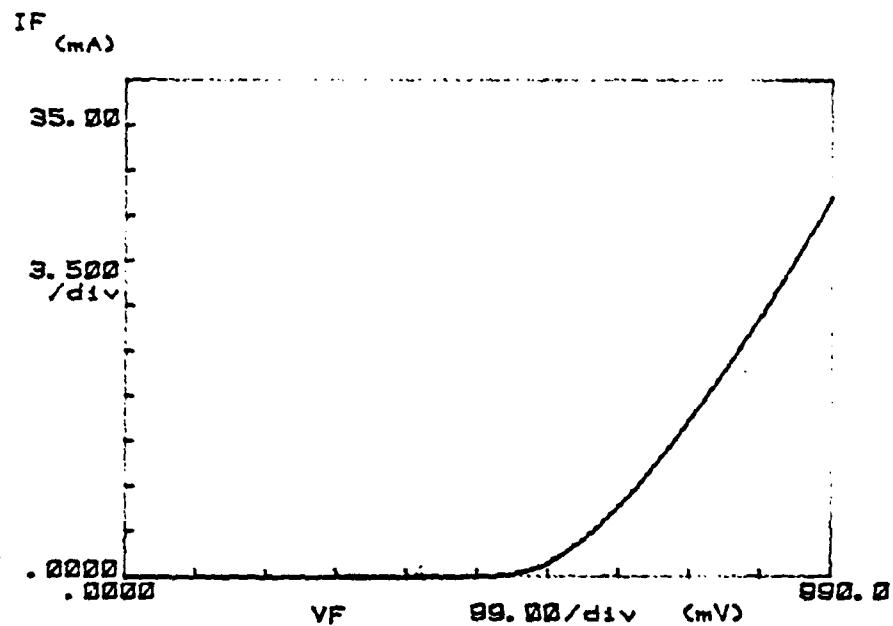
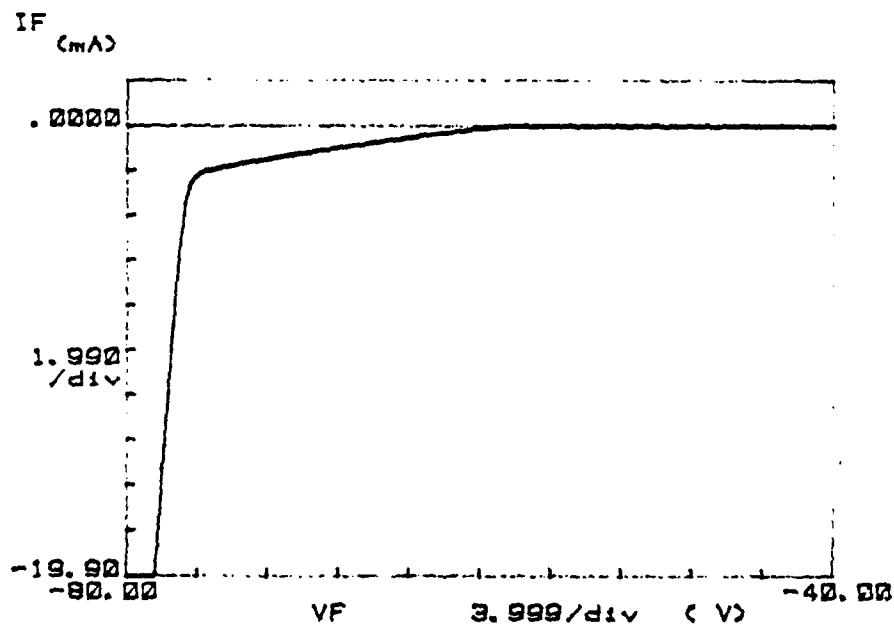
Figure 4. Current-voltage characteristics for diode 093.

Devices 051 to 100 were tested via the same equipment as described. Figure 4 shows the I-V characteristics for device No. 093, which accurately reflects the I-V curves for diodes 51 to 100. Note that these curves do not possess any of the possibly defect-related characteristics exhibited by the N+P+ diodes. In addition the avalanche breakdown voltage and turnover voltage in the forward directions between both sets of diodes is quite different.

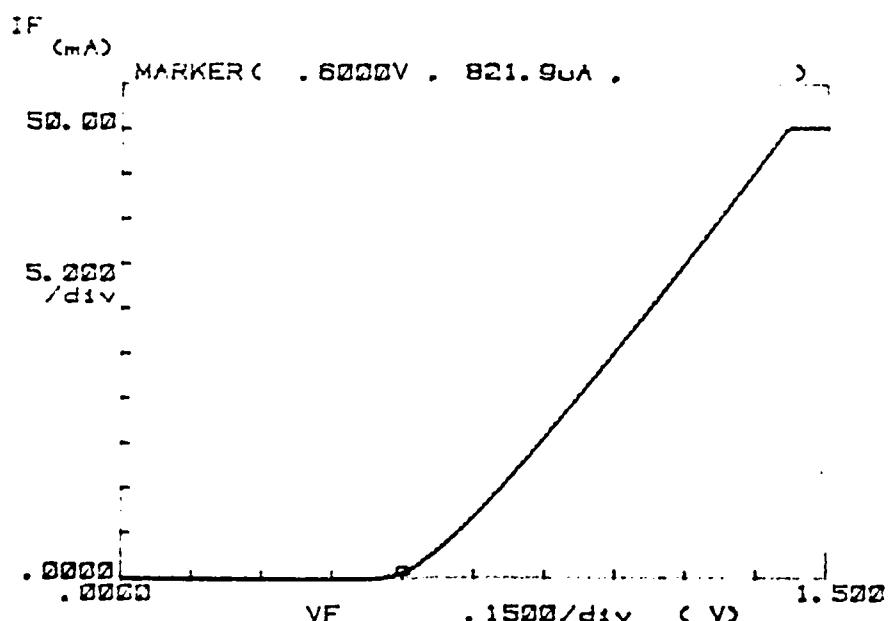
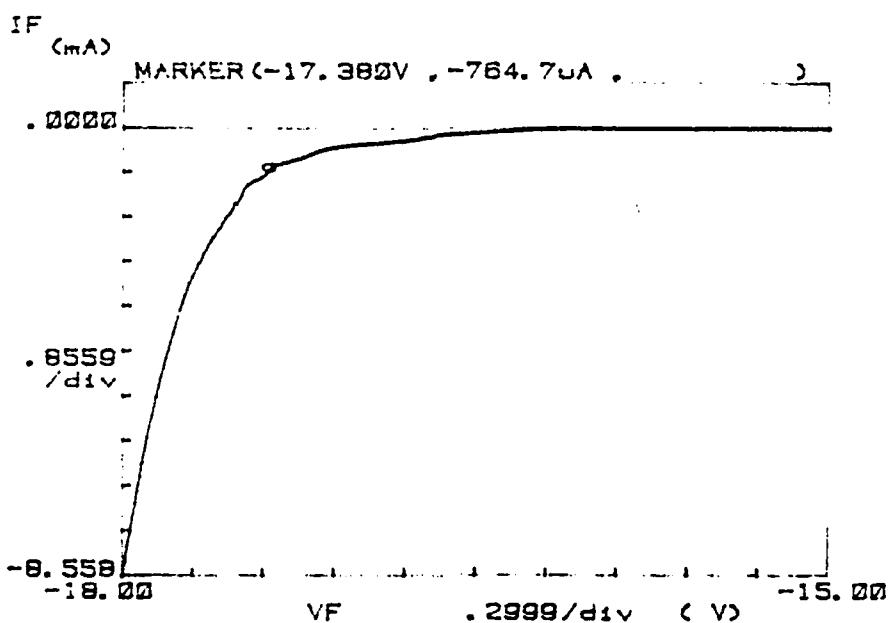
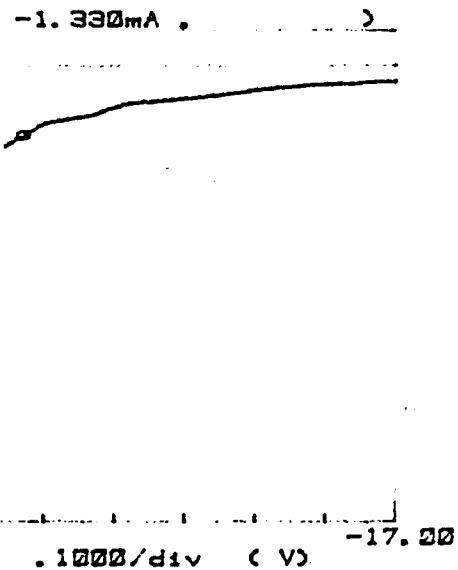
Figure 5. Current-voltage characteristics for diode 034.

The avalanche voltage of diode 034 is given by the addition of a soft breakdown knee with formation (Fig. 5c). These formations were characterized runs when diodes 001 through 050 reached the avalanche knee--that were not stable. Examination of diodes 001 through 050 at their avalanche breakdown voltage (despite the fact that it was at reverse currents which varied between diodes) went through the same production steps. All P+ diffusion may be the source of the characteristics. It was also determined that for both sets of devices were greatly reduced in one-sided step junction (Fig. 6). Thus, it does not appear to be solely dependent on

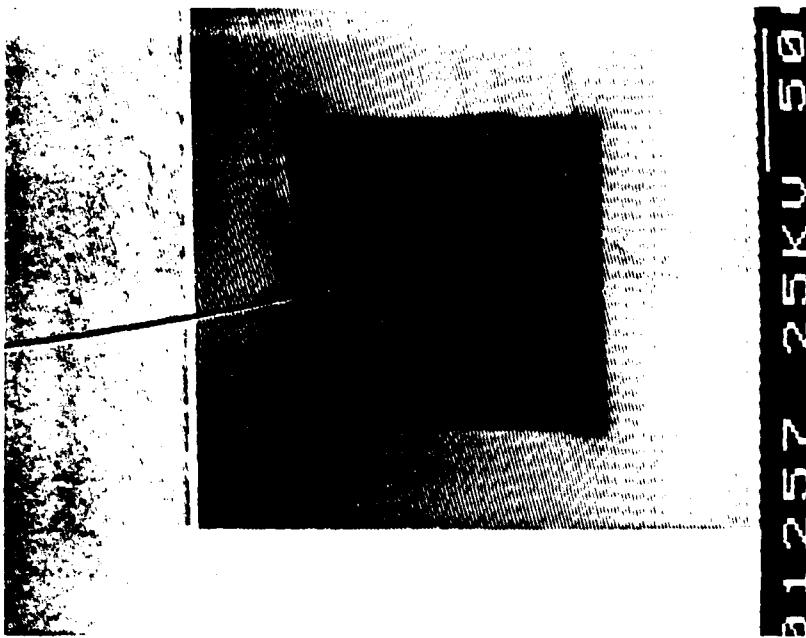
Figure 8. Voltage contrast imaging of device 100.

Figures 7 and 8 show devices 001 and 100 with a DC reverse bias of 30 and 100 V, respectively. It should be noted that portions of the image may be affected by device heating. This results in a blooming of the image which is a good sign of degradation. Retesting of these devices showed a definite electrical degradation in the reverse bias direction.

As Figs. 7 and 8 reveal, voltage contrast does not yield a high degree of resolution for the devices tested. Thus, continued work with the voltage contrast method appears to present a very limited method of collecting information.

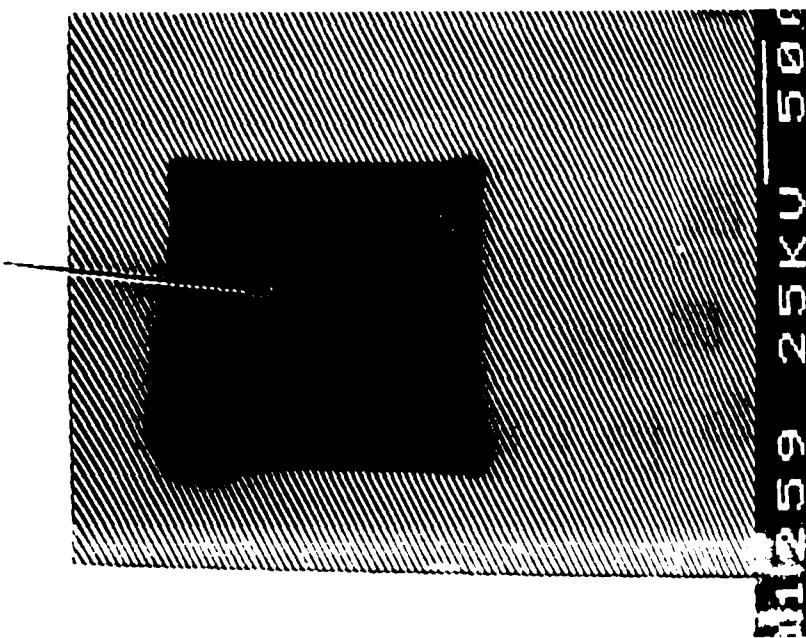
Figure 7. Voltage contrast imaging of device 001.

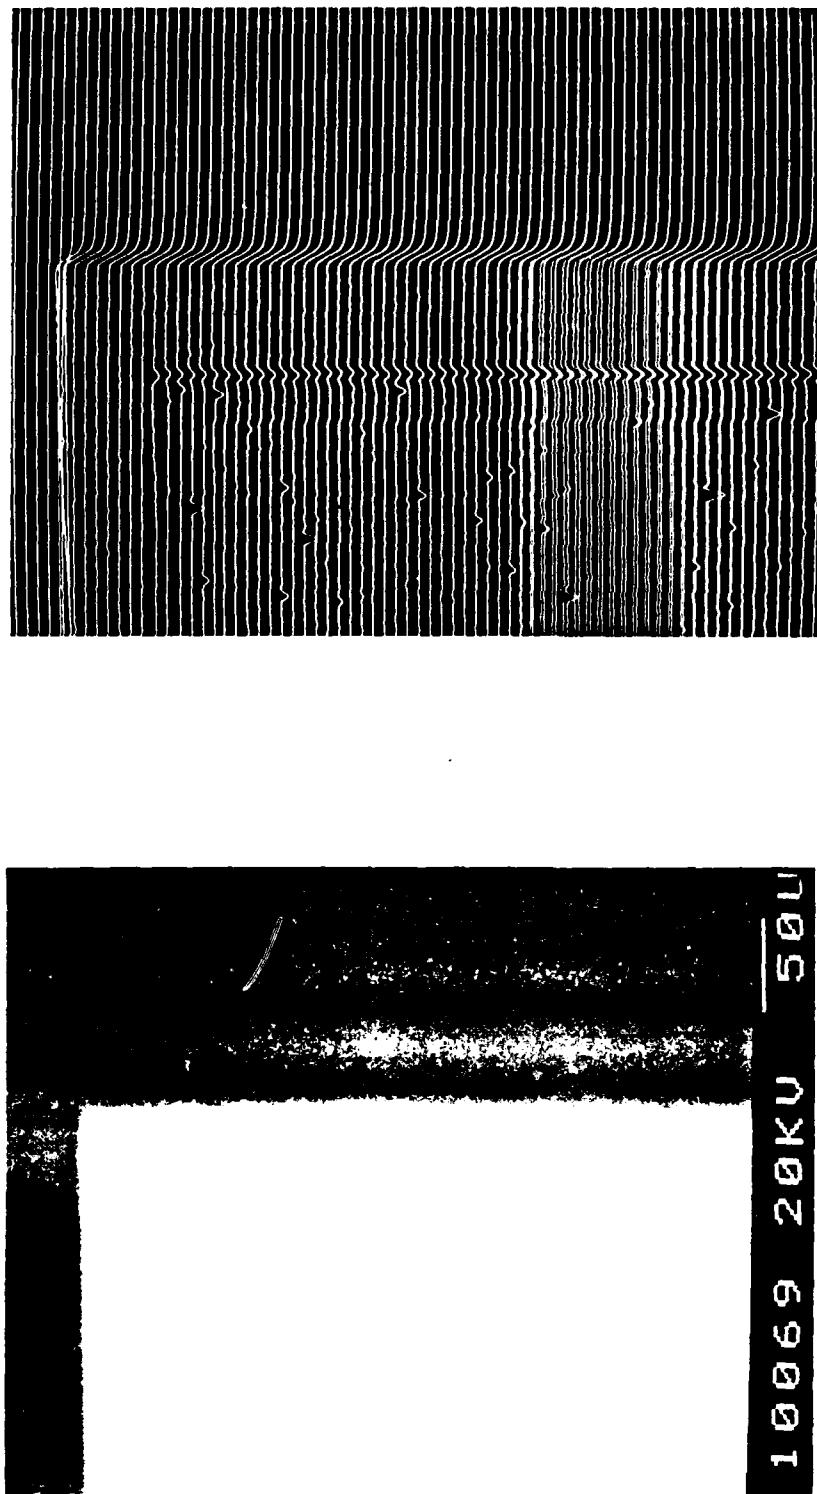
(a) EBIC image of device 042. The dark area to the right of the depletion region is an artifact generated by the electrometer's insufficient reaction time.

(b) Inverted line scan topography of device 042

Figure 11. The SEM image of device 042, 300x magnification.

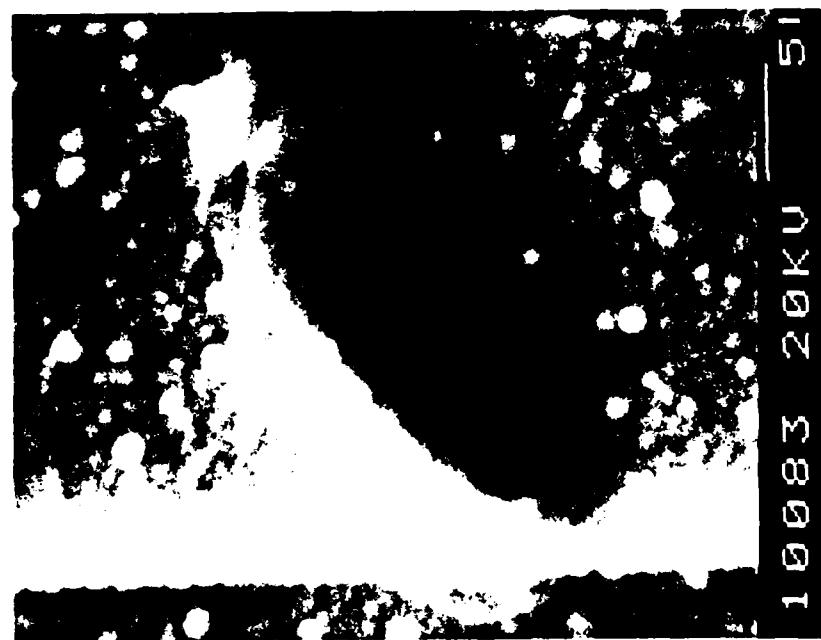
Device 009 had also experienced high voltage while attempting to achieve EBIC mode imaging. Preliminary checks before successful EBIC mode imaging did reveal some I-V changes, and a close examination of the surface revealed several possible abnormalities. Once again the surface granulation was readily apparent, but, observation of the right-hand side of this diode revealed an extrusion between the N+ and P+ regions of the diode (Fig. 15). This secondary imaging shows a definite extrusion that slightly affects EBIC mode imaging of the diode (Fig. 16). This extrusion is possibly an ejected melt due to second breakdown (Refs. 10 and 11). Although this extrusion should have a greater effect on electrical activity in the area (if it was caused by SB) EBIC mode imaging does not demonstrate any effect on local electrical activity.

Figure 15. Secondary electron image of device 009.

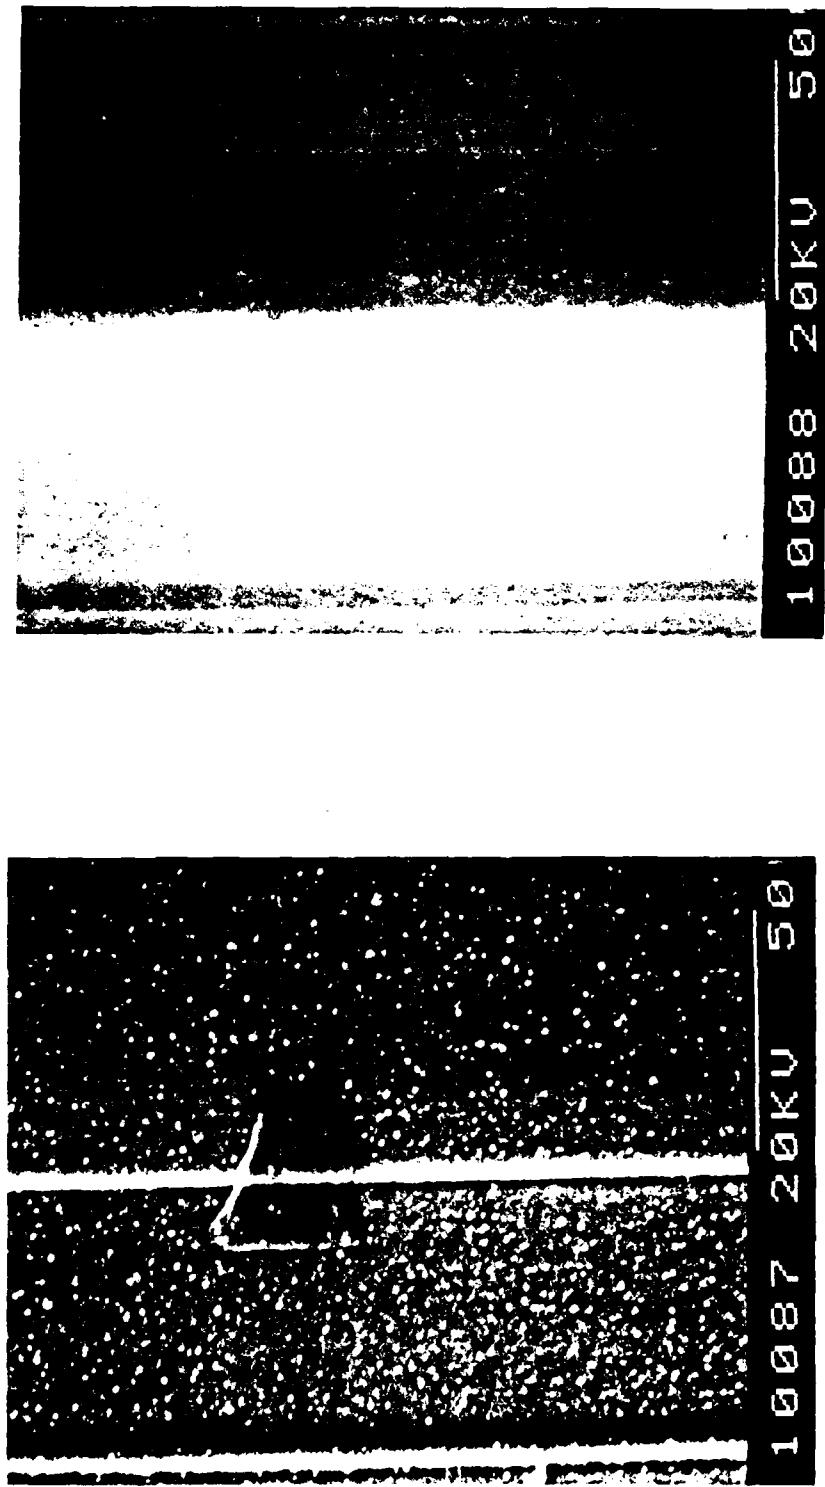
Farther down the diode edge from this extrusion, another extrusion appears (Fig. 17). This abnormality does seem to affect the EBIC mode image. Overdriving the electrometer brings this effect out most dramatically (Fig. 18a). Figures 18b and 19a show a depression that was found on the device's lower edge between the metallization and N+ diffusion. The EBIC imaging of this area showed no electrical abnormalities. The lower left-hand corner of the device metallization showed a distinct pitting between the metallization and N+ diffusion (Fig. 19b). This pitting (which is seen on other predamaged diodes in this report) may be the result of oxide contaminant thermal activation or metallic migration.

Figure 17. Secondary and EBIC image of second defect on device 009.

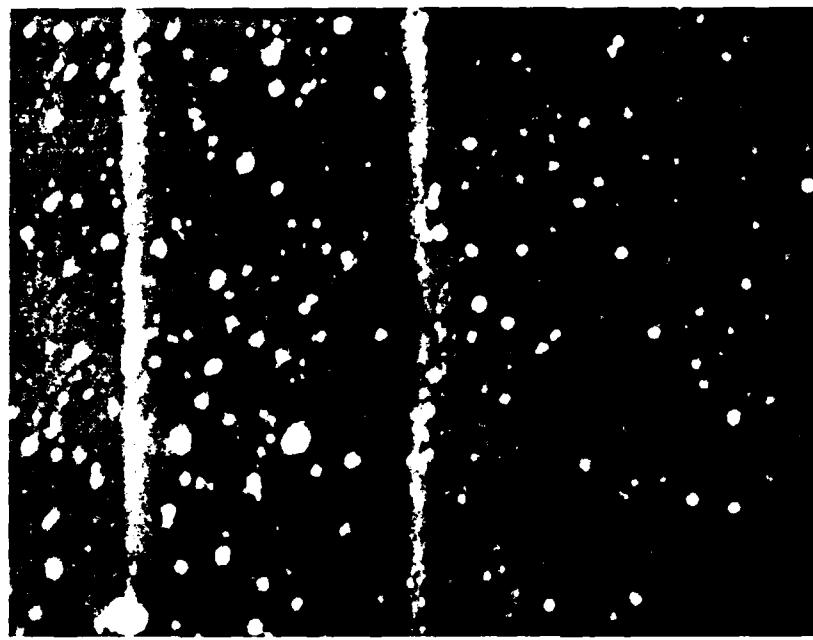
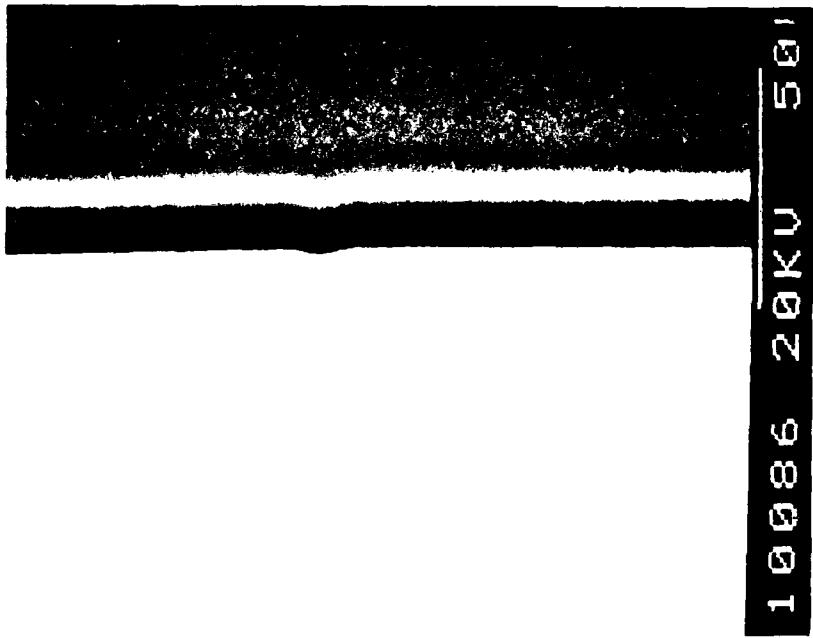
Figure 18. (a) Intensified EBIC image of second defect, (b) Secondary electron image of third defect on diode 009 at 2000x.

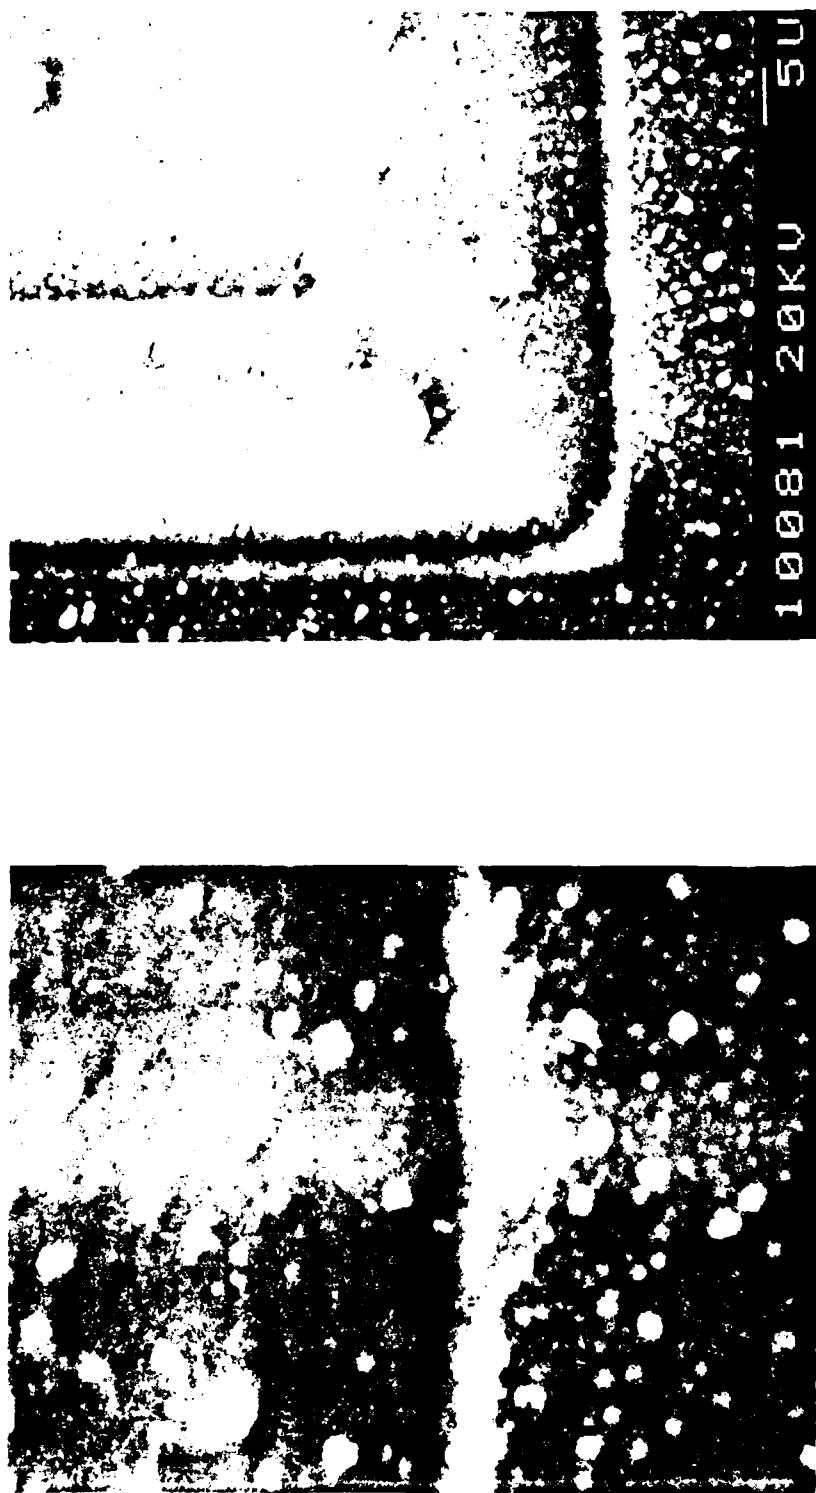
Figure 19. (a) Secondary image of the third defect on device 009 at 4000x,  
(b) Secondary image of metallization pits on diode 009 at 2000x.

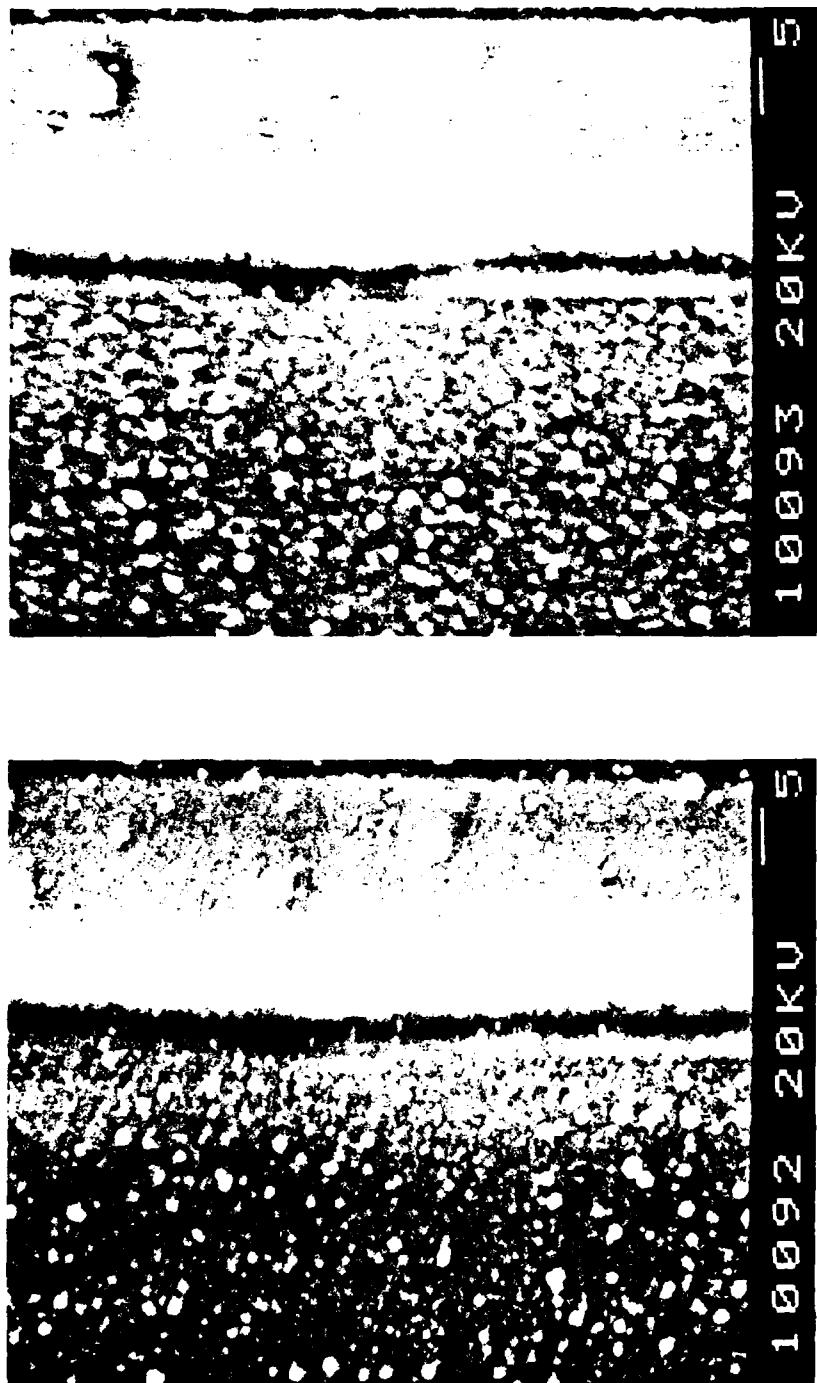
Figure 20. Secondary image of metallization pits on device 011 at 2000x.

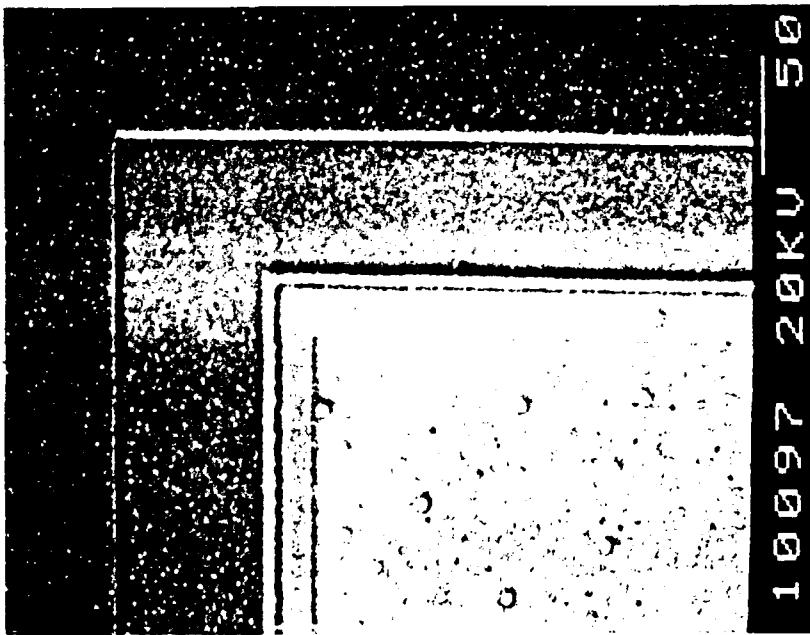
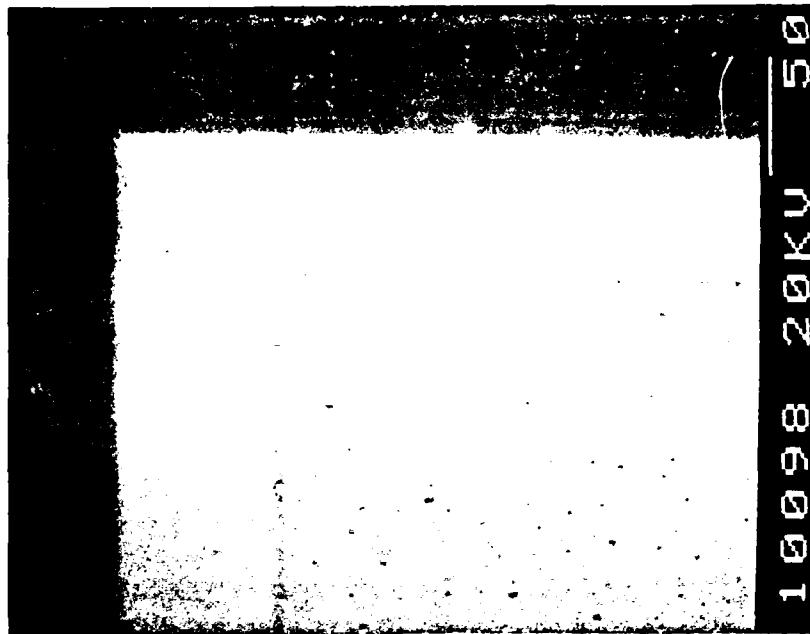
Device 011 (also predamaged) showed extreme pitting all along the periphery of the metallization (Fig. 20). Only two photographs of these pits are shown as representative of this effect. The EBIC mode imaging of this diode showed no irregularities (Fig. 21).

Figure 21. (a) Secondary image of diode 011 at 400x. (b) EBIC image of diode 011 at 400x.

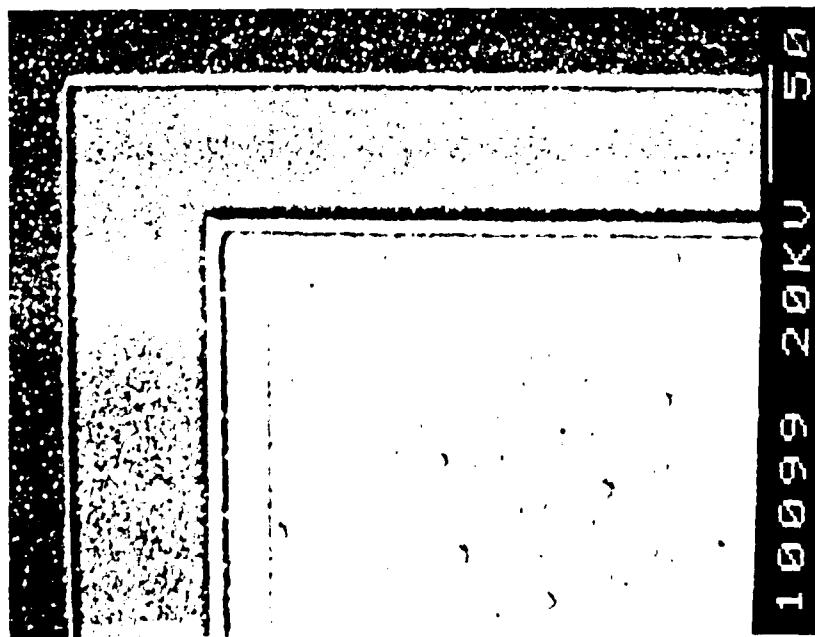
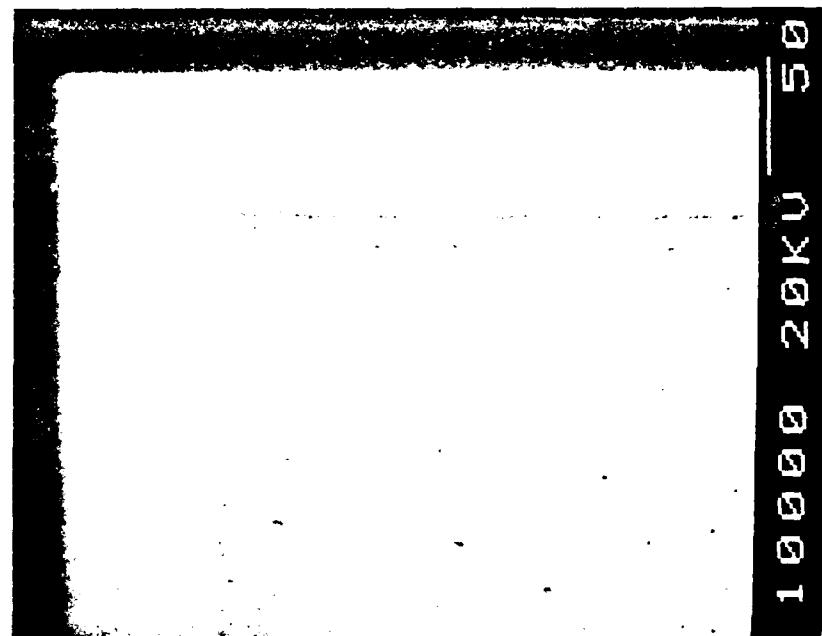
Device 018 (also predamaged) showed no abnormalities in EBIC or secondary mode imaging (Fig. 22).

Figure 22. (a) Secondary image of diode 018 at 400x. (b) EBIC image of diode 018 at 400x.

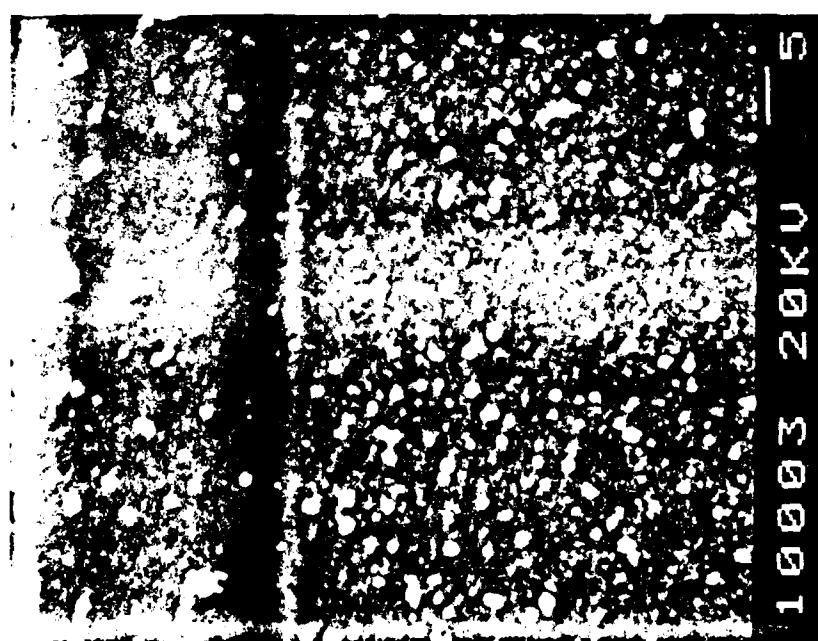
Device 100 had been viewed using the voltage contrast method discussed earlier in this report. Thus, the device was suspected of being damaged due to the applied voltage. Secondary imaging showed numerous pits along the metallization periphery (Fig. 23); yet, no abnormalities were seen using EBIC mode imaging. Figure 24 shows the upper right-hand corner under EBIC mode imaging which brings out the distinctive depletion region of the device. It was also noted that this diode exhibited a great deal of surface charging. This effect may be caused by surface damage to the diode although this cannot be verified at this time.

Figure 23. Secondary image of metallization pits on diode 100.

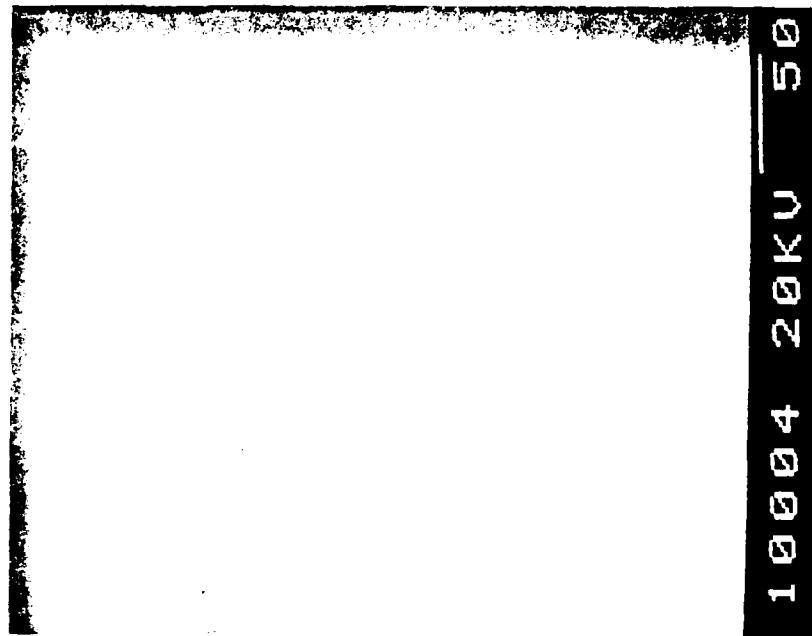
Figure 24. EBIC image of diode 100 at 400x.

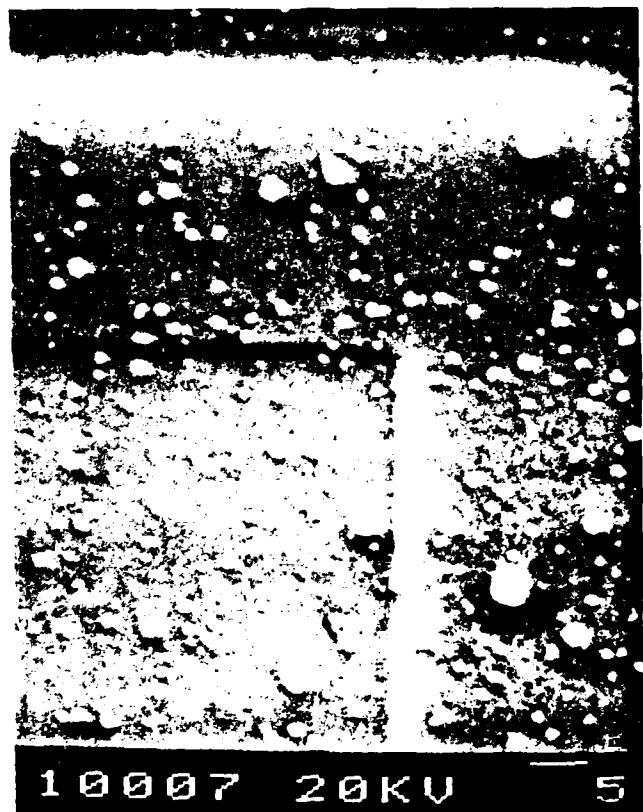
Device 097 was an early casualty to poor initial attempts to obtain voltage contrast measurements. Voltages in excess of 75 V were applied to this device in taking unsuccessful voltage contrast images. Observation using secondary

Figure 26. Secondary image of metallization pits on diode 097.

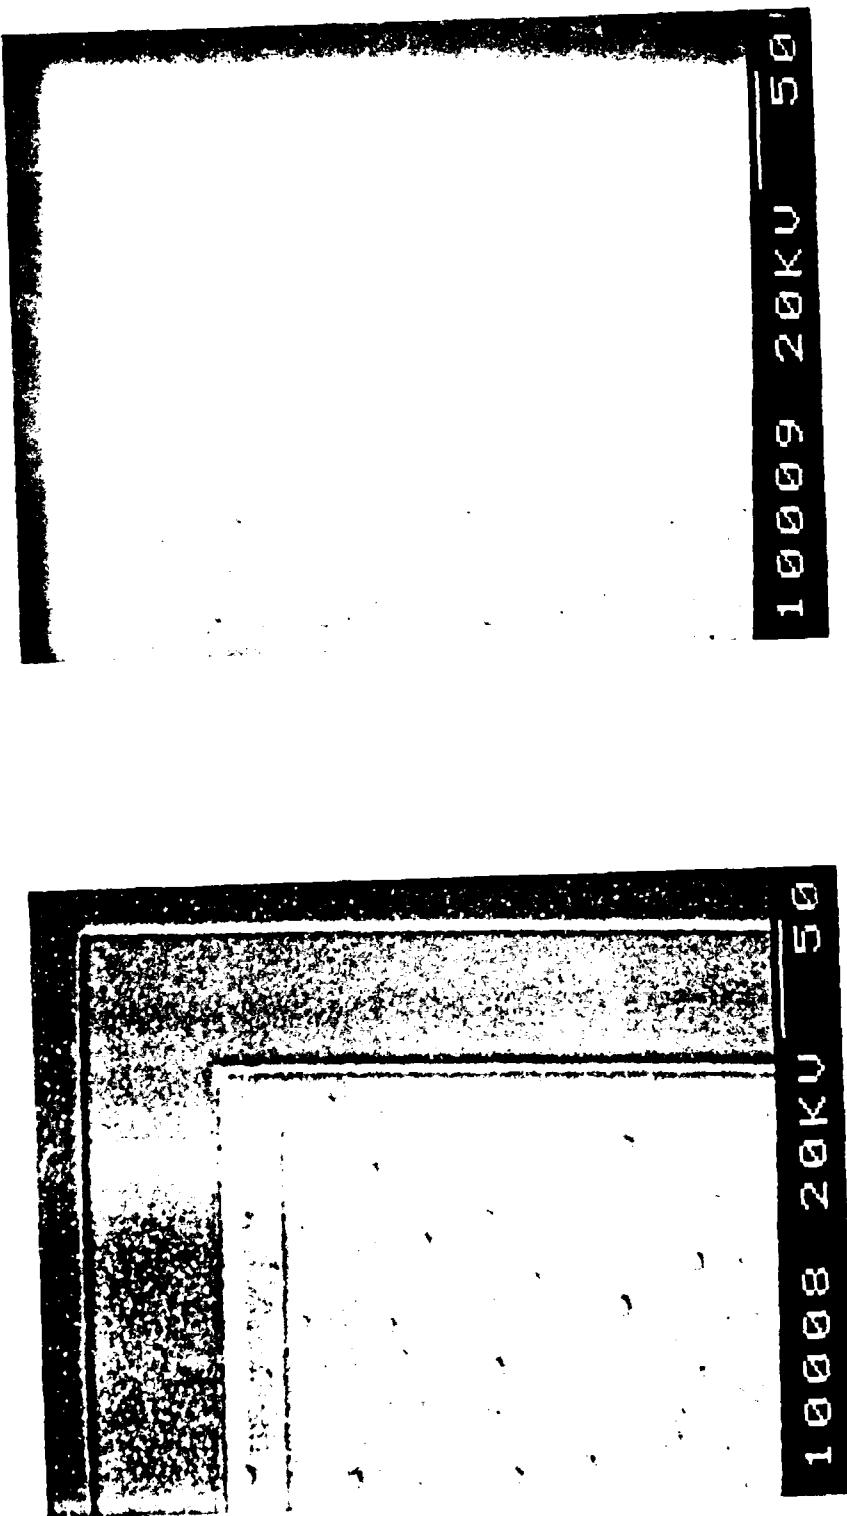
Figure 27. (a) Secondary and (b) EBIC image of diode 097.

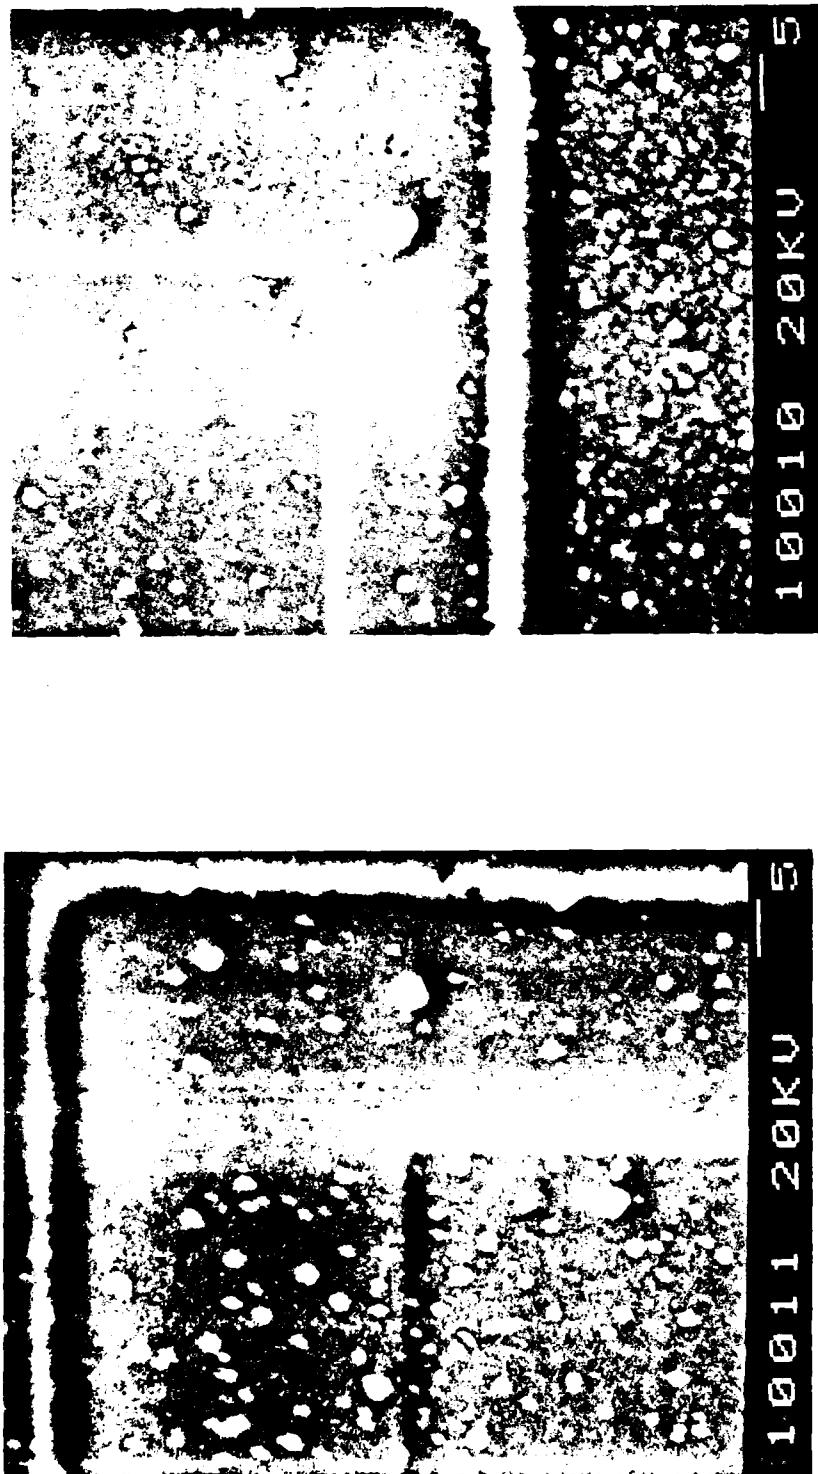
Figure 28. Secondary image of metallization pits on diode 042 at 2000x.

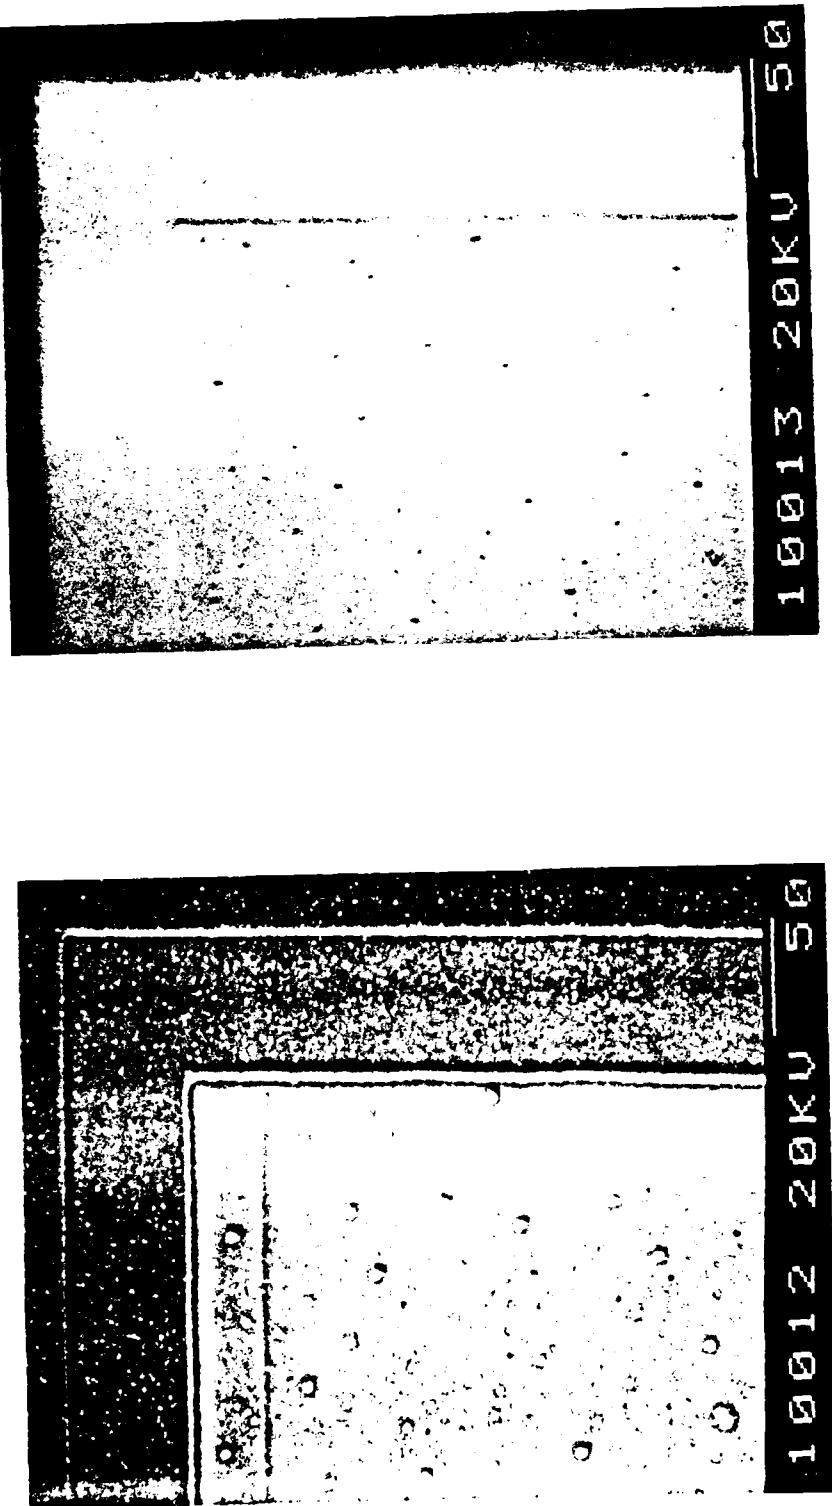
Figure 29. (a) Secondary and (b) EBIC image of diode 042.

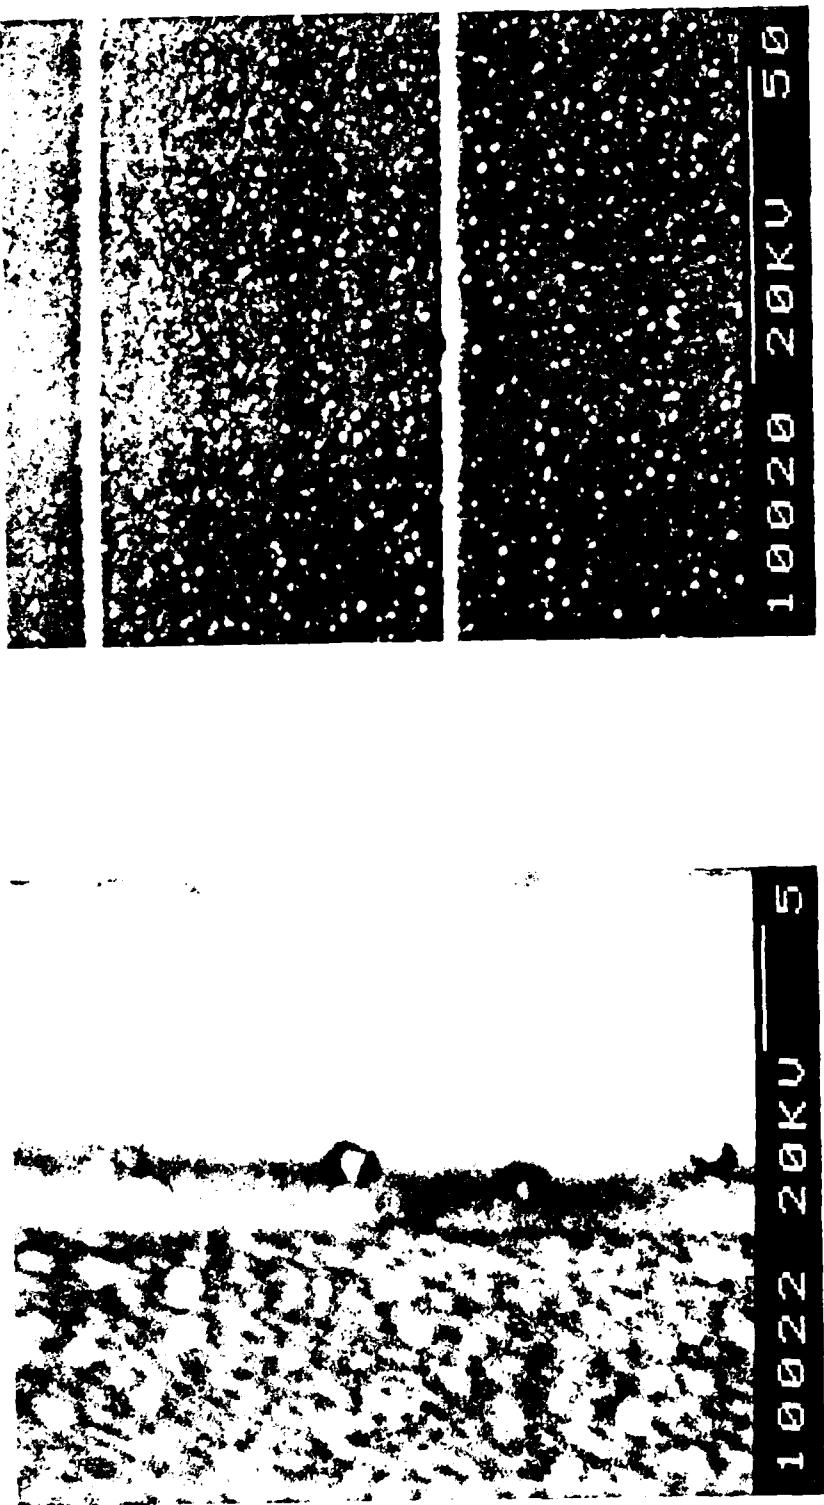
Figure 30. (a) Secondary image of metallization pits on diode 046 at 4000x.  
(b) Secondary image of diffusion edge defect on diode 046 at 1000x.

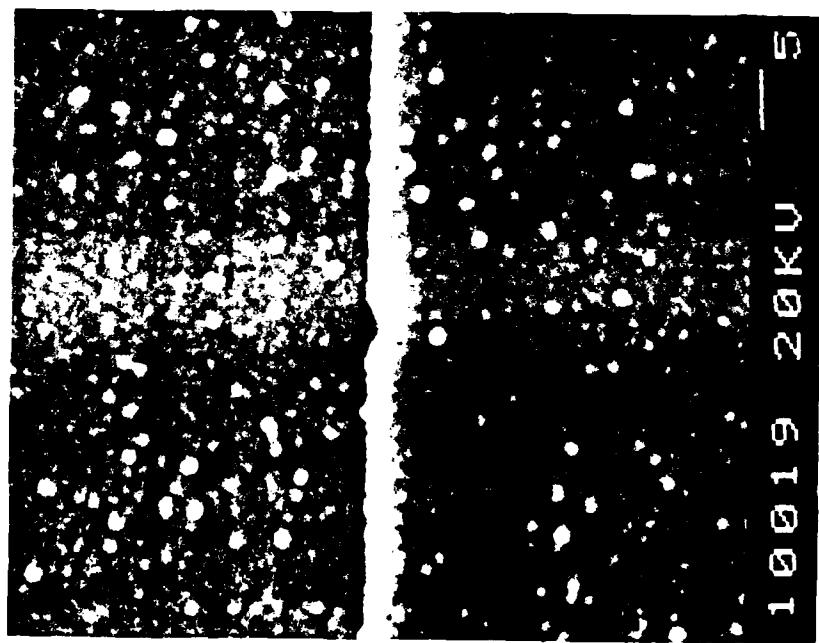
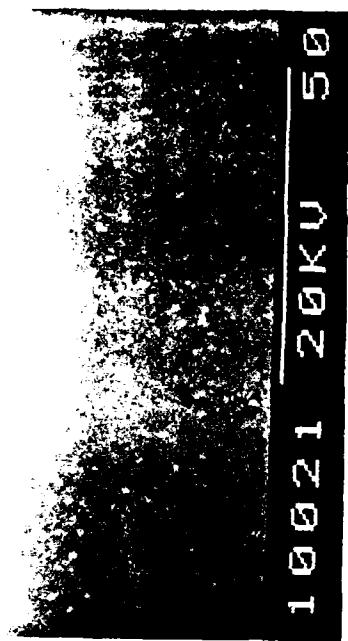
of pits on the metallization periphery of device 042 (Fig. 30a). Secondary imaging shows a diffusion boundary, where a surface layer has been removed, and an EBIC mode photograph of this defect shows a dark, irregular region near the layer edge (Fig. 31b). This location is shown in Fig. 32. Figure 32 shows the secondary and EBIC mode

Figure 31. (a) Secondary image of diffusion edge defect on diode 046 at 20000x.  
(b) Intensified EBIC image of edge defect on diode 046 at 10000x.

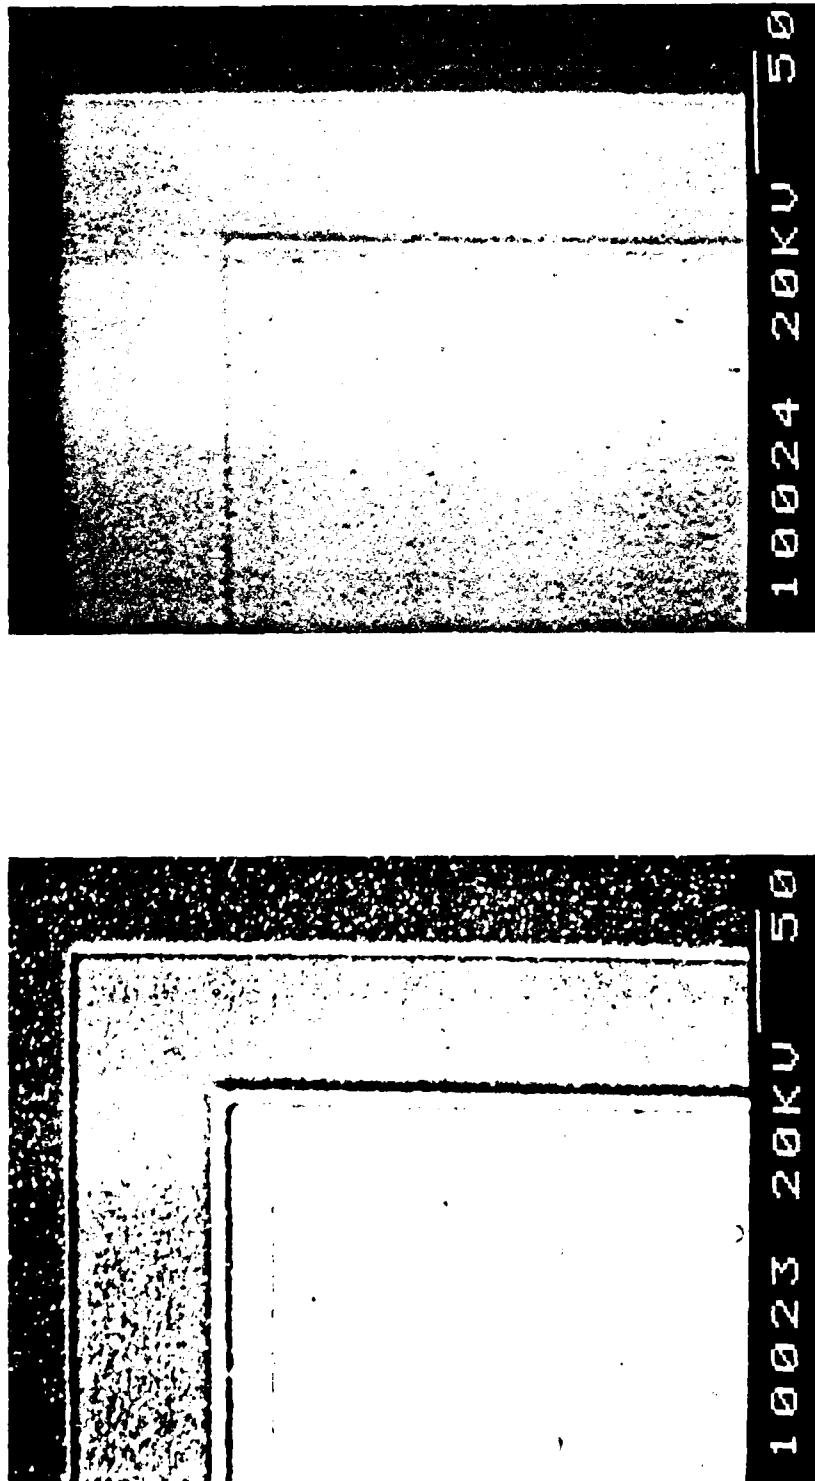
Figure 32. (a) Secondary image of diode 046. (b) EBIC image of diode 046.

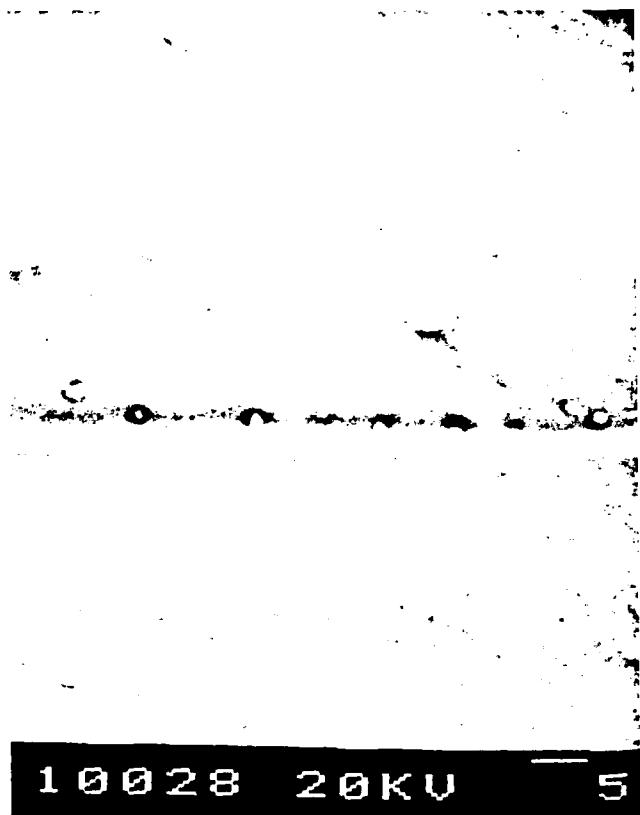
Figure 33. Secondary image of metallization pits on diode 081 at 2000x.
